Special Report: Restoration of D&RG Pullman Tourist Sleeper 470 Part 1: 2009–2015

The Restoration of D&RG Tourist Sleeper 470 Friends Project 1115 Part 1: 2009–2015

Steel Support for Wood Frame Structure, 2010–2013 by John Eng

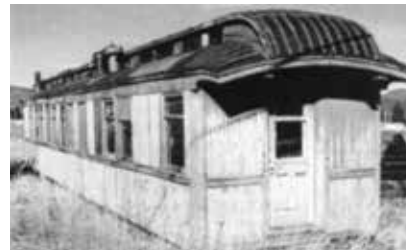
252 in Chama, C&TS Dispatch, 1996

In the early 1990s, railroad employee Earl Knoob made a structural inventory and evaluation of the car in Chama. He concluded that "The car is in remarkable shape considering its age and the weather extremes it has been subject to... However, considerable work must be done..." He recommended that the governing Board of the Friends of the Cumbres & Toltec Scenic Railroad should consider purchasing the car for future restoration.

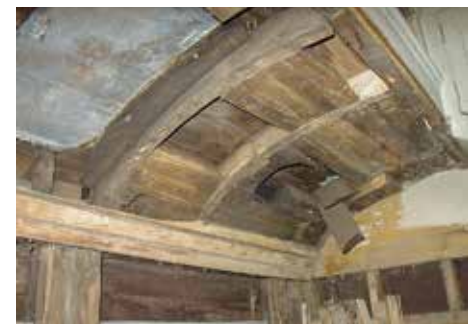
Not all the car is wooden construction. There are truss rods that extend through the framing at intervals throughout the car, both vertically and horizontally. The horizontal rods pass through the floor sills and are fixed at each end of the sills. The vertical truss rods pass through the wall framing between the windows. There

are also vertical truss rods attaching the structural framing to the sills. These were all revealed as the interior and exterior surfaces were removed, exposing the skeleton frame of the car.

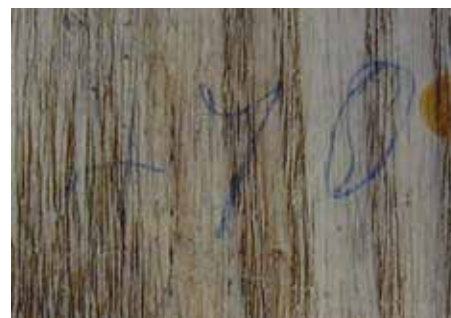
During the deconstruction, Craig found the number "470" penciled inside several of siding boards, confirming that this car was indeed Tourist Sleeper 470, the last of that series of cars built by Pullman. No longer was she Car 0252.

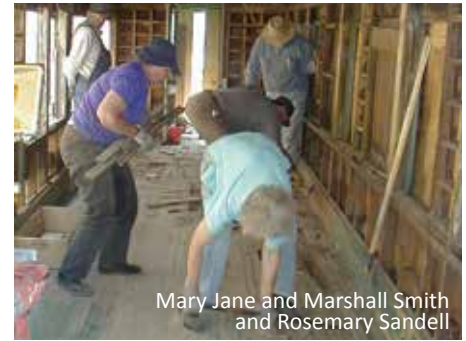
The crew attacked the floor and found two layers of flooring on top of the frame sills, as well as sheeting on the underside of the car. With the floor removed, they could see the complex framing and arrangement of some of the truss rods that kept the car square and intact.

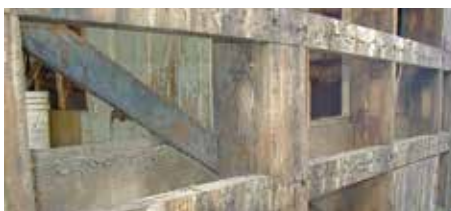
On a layer below the top layer of flooring, there was an inset plaque with the letters "D&RGRR," and the date "1887." The plaque covered the kingpin for the trucks at the bolster at one end of the car. There was no similar casting at the other end, though it may have been lost. 1887 was when the plate was cast and the D&RG began receiving the car fleet. It's believed that No. 470 was built in 1889, the last of the series. Later, repairs were made to damaged sills and the plaque was probably replaced with the earlier casting.

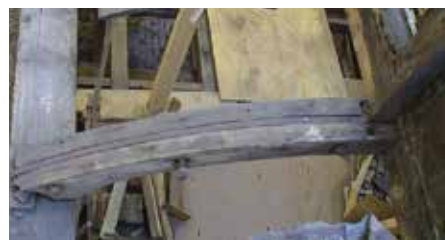
Steel arch braces in the roof structure, spaced periodically between the wooden

roof arches, are called carlines. They provide support for the framing between clerestory windows that run the length of the roof of the car, then follow the curve of the roof below the clerestory and are fastened to the sill plate at the roof edge.

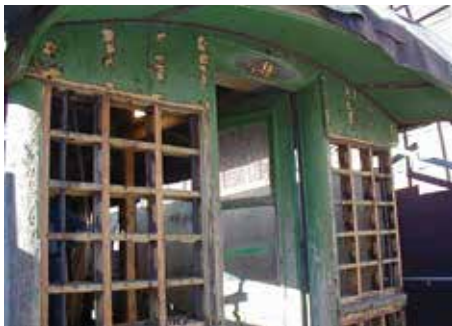
The ends of the car have their own unique framing that was exposed when the original tongue-and-groove sheathing was removed.

Notice the #9 above the door from its time on the Colorado & Northwestern Railroad.

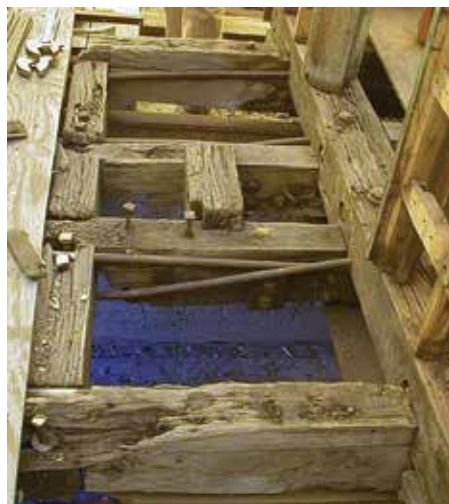
With the metal sheathing gone, the roof decking was evaluated and while much of it wasn't in terrible shape, it was decided to replace the decking on the entire car.

Meanwhile, Craig and Ray Hoppes began dismantling the west end of the car. George Boyson and Rich Weitzel removed the end platform and cleaned up the framing. Some large framing members, including one of the outer sills, were fully rotted and in need of replacement.

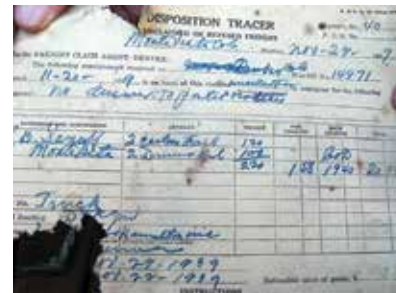
This Disposition Tracer was found while dismantling the west end roof. Dated November 29, 1939, it is from when D&RGW 0252 was an Outfit Car for maintenance of way crews. During that period it served as a temporary Railway Express Agency office several times during remodels of various stations in the D&RGW system.

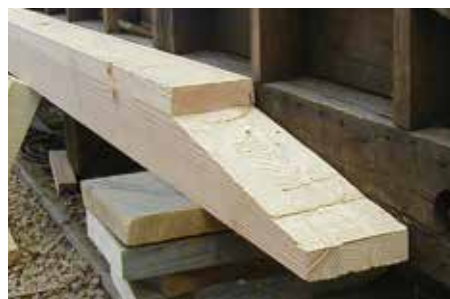
The sill needing replacement is the lower one adjacent to the new beam (below.) The splice was tapered at the joint to fit seamlessly with

the original sill and notched to prevent movement when in motion or during hard impact events such as coupling.

Before it could be installed, however, it had to be decided how to remove the old sill and create the mortise holes for the uprights in the replaced piece.

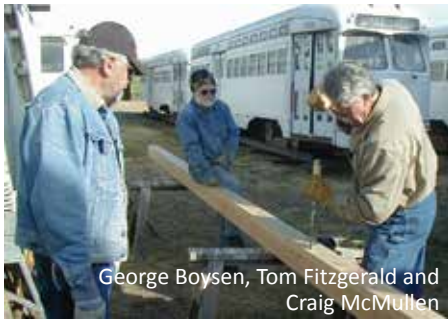
George Boysen, Tom Fitzgerald and Craig McMullen

Craig also constructed new arched carlines to replace the existing members supporting the roof below the clerestory.

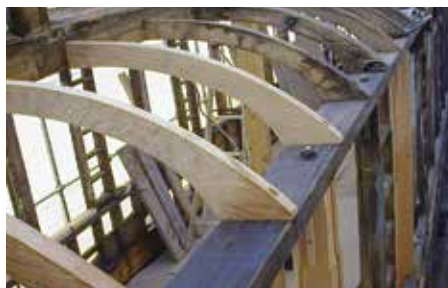
Installed, one can see the deteriorated members have been replaced. They appear lighter than the old ones.

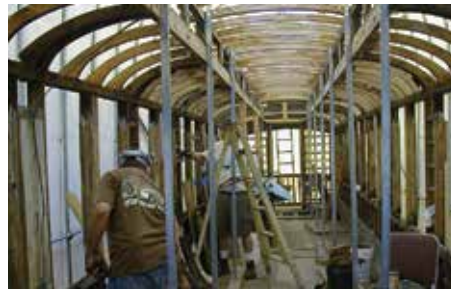
On both ends of the car's interior there was a storage cabinet that also included a small mysterious hole. The hole was for a pull cord to the locomotive for an emergency warning or stop signal.

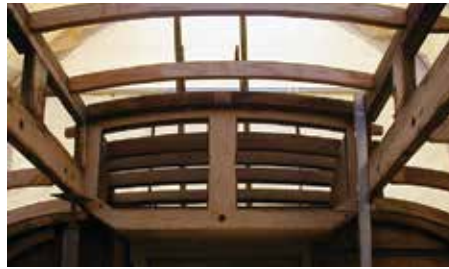
New framing was added to one end of the car. The other end is slated for replacement in the future.

Along with the car ends, new body bolster compression beam braces were installed in several locations around the car's sides where older bars appeared to be questionable. The severely-rotted side sill can be seen below the new compression beam.

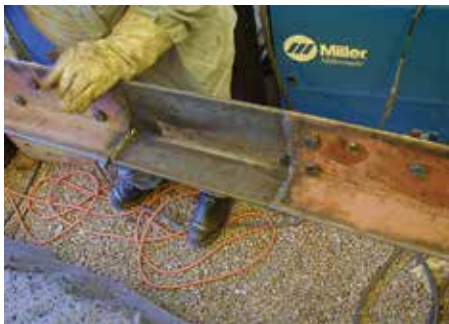
Final Design Drawn by Glenn Hall, August 6, 2011

the two individual joints. With the center joints completed on both sets, it was time to remove all wood cross bracing between the intermediate and center sills as well as pulling out all horizontal tie rods to free access to the outside of both center sills.

The next step was to test-fit the steel to each center sill for marking. A long center punch was used to mark each tie-rod location approximately every two feet down the car. It was also

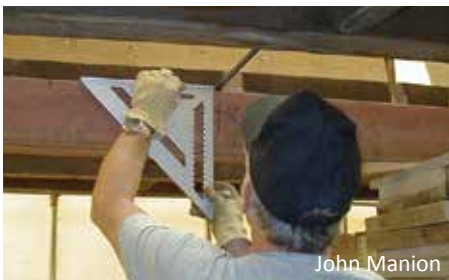
necessary to mark locations on the steel where the "ladder rung" system (similar to an extension ladder) could pass through without obstruction from wood bracing or tie rods. This

design would use the steel like the rails in a ladder and utilize Schedule 80, 1" pipe for the rungs.

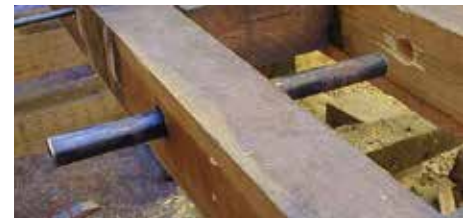
After the rungs were drilled, the tie rods were again pulled free and the steel angle was again removed. At that point it was necessary to align the two holes drilled through the two wood sills for the rungs, again using a $\frac{13}{16}$ " bit. Next, each of the rung holes through both sills were enlarged to $1\frac{1}{4}$ " which would accept the Schedule 80, 1" pipe.

With that complete, the pipe rungs were ready to install. Each rung was cut to a specific length, measured from outside to outside on the center sills at each rung location. The cut pipe was slid into position and the steel angles were installed for the last time. Each move of the steel angle took six people because of its length and weight.

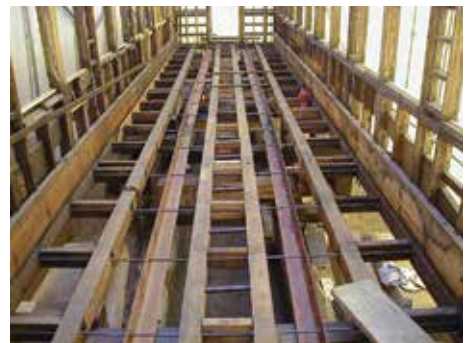
Each angle iron was fit into position and tie rods pushed through to the outside sill. Then $\frac{3}{4}$ " rod was used to align each rung position.

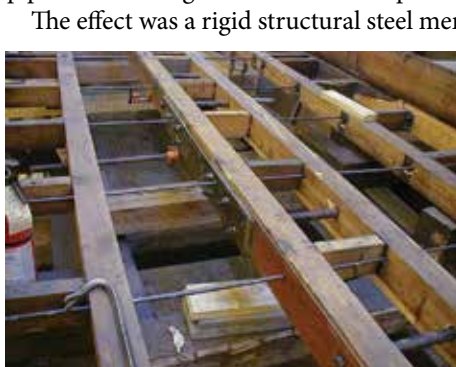
Special high tensile Grade-8 bolts, 3/4" in diameter, were installed to compress the steel together, against the Schedule 80 pipe. Each was tightened to 200 foot-pounds.

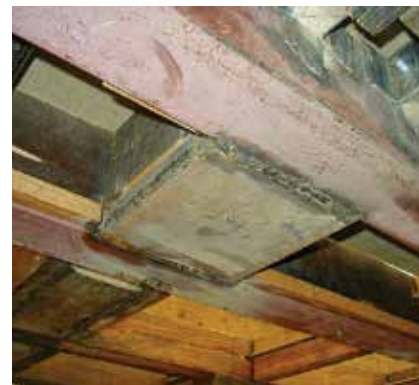
The next challenge was to manufacture three-tab saddles to hold wood cross-bracing from the intermediate sill. The saddles would then be welded into position on the steel angle at each cross-brace location. Each of the cross braces removed previously were shortened and reused to fit in the saddle, which amounted to approximately a 3/4" cutoff.

With these steel additions in place, 470's undercarriage was now strengthened and could eventually become part of safe, strong passenger train while at the same time maintaining its historical character.

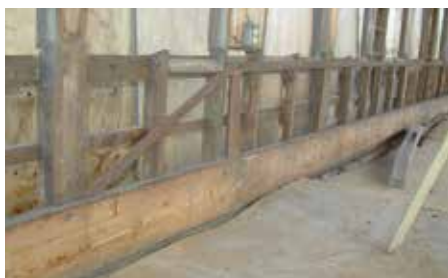
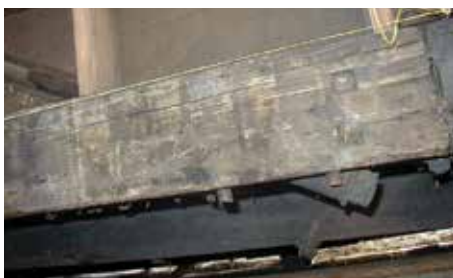
Each end is anchored through the sill at the end of the car and each end of the brace has threaded tie rods that pass through the sill, capped with now well-rusted nuts.

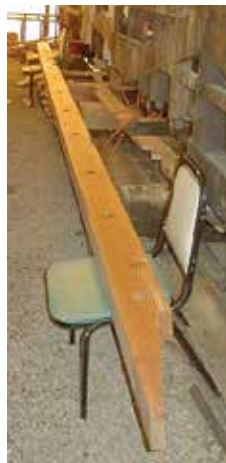
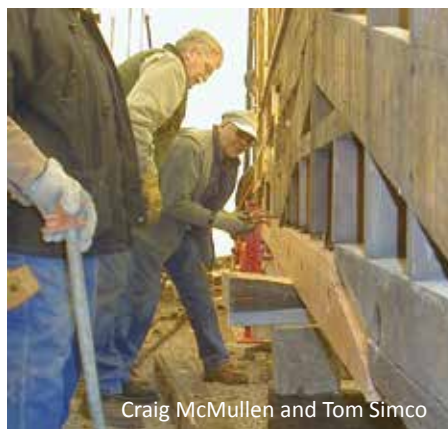
January: Out with the old, in with the new... side sill. The tapered splice to join the old and new portions of the sill was really quite impressive.

On New Year's Eve day, several hardy souls removed the east half of the north sill that had rotted from the water from the icebox. On the first work day of the new year the new sill was fitted in place.

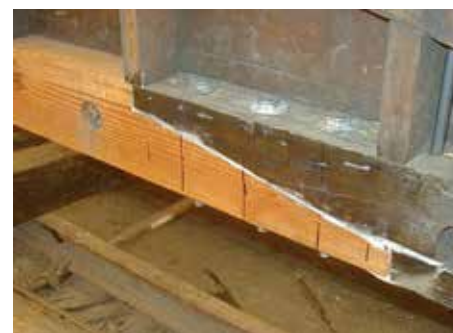
The framing was mortised into the top of the old and new sills. The remain-

ing undamaged section of the original sill was joined with the new piece with a long taper.

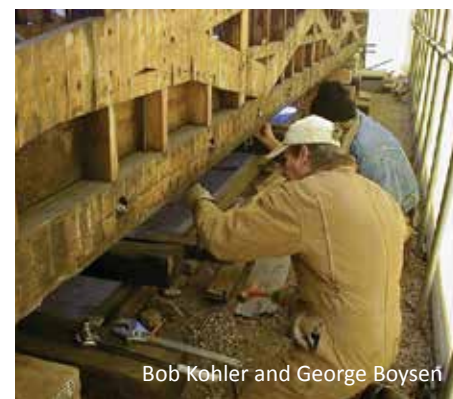
The ends of the tapers were squared off to prevent slippage with compression forces. The joint between the old and new portions of the sill were secured with epoxy and bolted with three bolts.

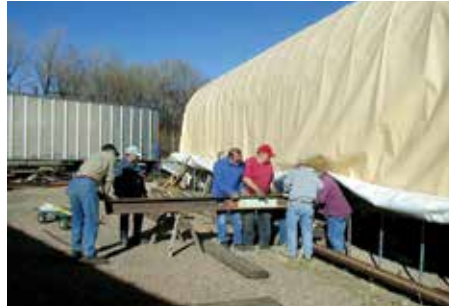
At this point, the structural steel frame reinforcement had not yet been installed so the ends of the car tended to droop due to the flexibility of the still-wooden frame.

I-beams were placed under the car where the bolsters (and trucks) would be, creating a solid base. The car was jacked up to make room for the I-beams and the two-year steel frame reinforcement work described on pp. 13-15 could now begin.

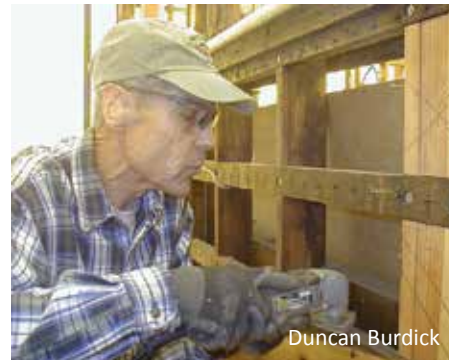
The original stabilizing blocks in the sides of the car were glued in place with old-style horse-hide-based glue. Duncan Burdick sanded out the glue so the new blocks would fit.

The new blocks were then set in place. The small triangular pieces fit inside the car behind the block and were glued to the block and the frame.

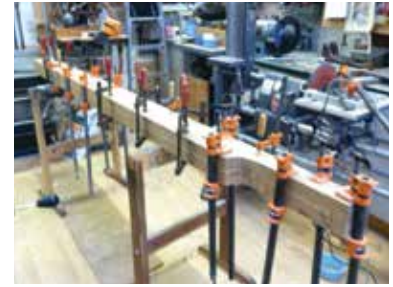
Both end platforms were in very poor condition, largely rotted out due to their exposure to the elements. However, the sills under the main portion of the car, now strengthened, do not extend to include the platforms. Instead, they are supported by sill extensions attached to the main sills. New end sills were needed to replace the thoroughly rotten end platforms.

Craig cut and laminated the sill extensions in his shop.

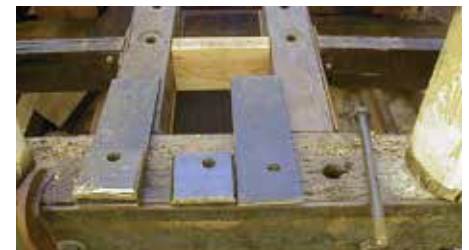
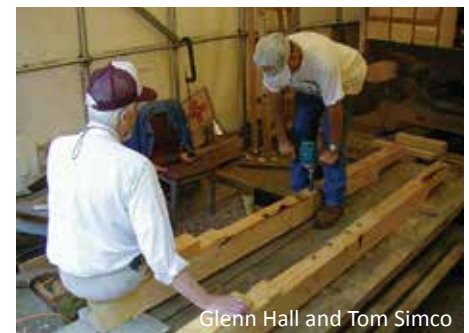
The end sills were then drilled for installation with the car sills and checked before final assembly.

To attach the sill extensions to the existing sills required some steel joints and the sills notched to receive them.

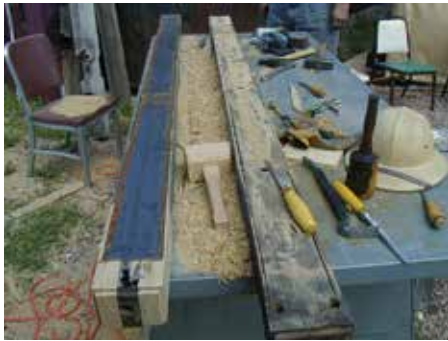
Part of the supporting frame on the underside of the car is the needle beam that supports the queen posts, which in turn support the under-car truss rods that carry the center weight of the car.

Because of their integral role in the overall strength of the car, the existing needle beams were reinforced with new steel channel material. The work with the needle beams would resume when the tie rods were ready for installation.

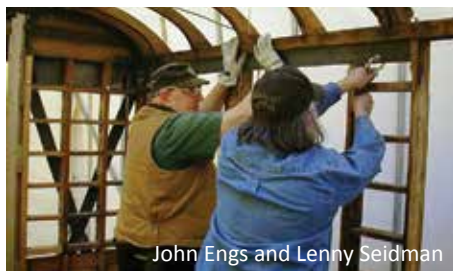
Some of the last pieces of steel fitted were braces in the upper corners of the car, adding strength and stability by creating a "structural box."

One end was bent at a ninety-degree angle and welded to the inside of the plate secured to the end of the car. The other end was welded to an angle piece bolted to the upper sill.

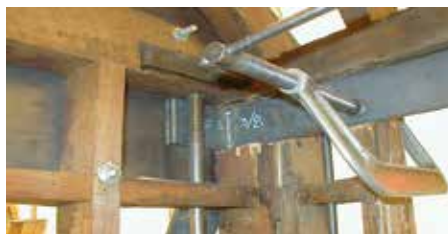
Welding of all the steel pieces was completed to make a continuous steel frame from coupler to coupler as required by FRA regulations.

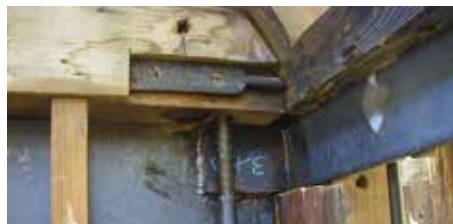
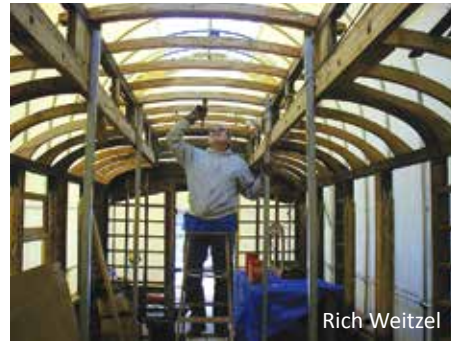
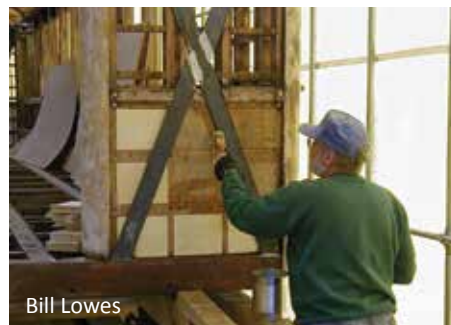
Interior and exterior wooden members of the car that would not be protected with primer and paint were given a sealant coat of linseed oil.

This included the interior wooden carlines of the room and the clerestory and

the stability blocks between the framing on the sides and ends of the car.

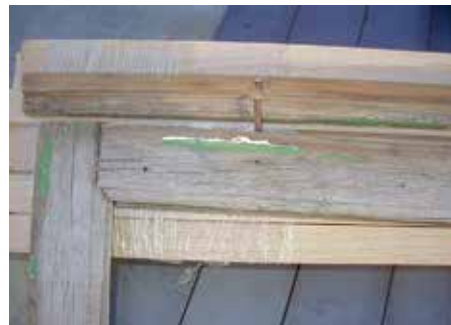
Continuing with a project begun back in 2011, Craig was building 470's window frames in his shop.

The original upper frame was held in place with a peg that fits into a groove in the wood above. The upper frames were put in place by inserting the peg in the groove, then pushing the lower part in over the shelf in the molding along the side of the window. They could be removed if needed to replace glass by reversing the process.

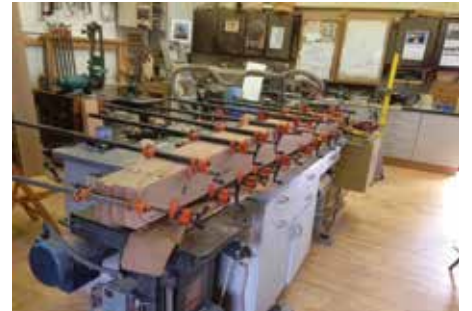
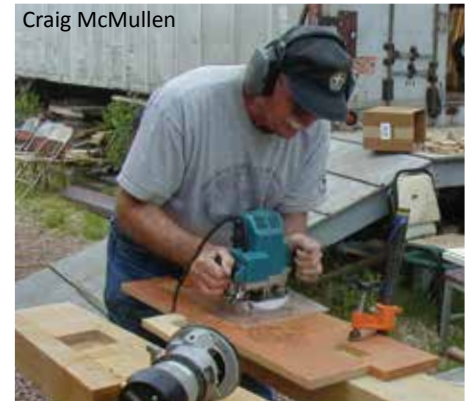
One of the car's end platforms was completed last year. Now, the second

installation took place. The second set of sill extensions was completed in Craig's shop, made with multiple laminated layers of white oak.

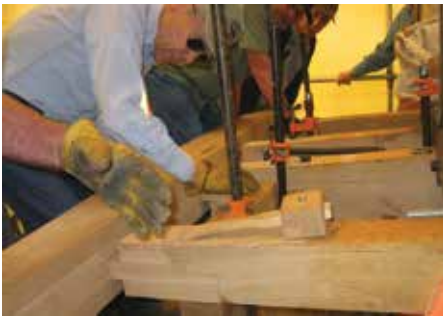
It took a bunch of stalwart guys to lift the heavy end sill into place.

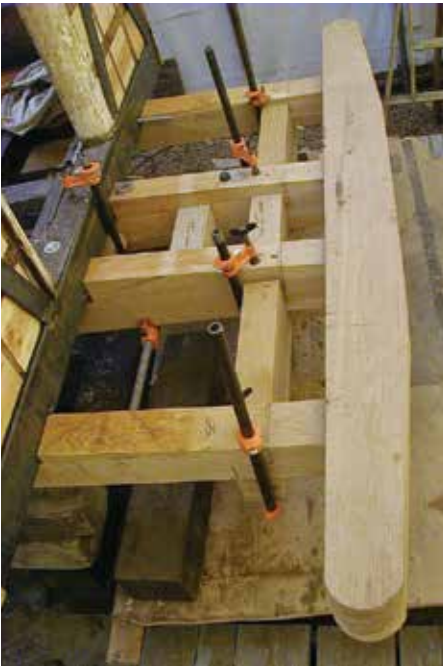
The tenons were then slipped into the mortise holes.
In the end, it was a perfect fit!

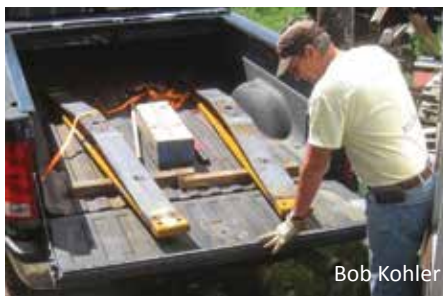
A group of volunteers traveled to the Ulrich Locomotive Works in Strasburg, Colorado, who fabricated replica bolster parts based on the bolsters that had been removed from the car when it was scrapped.

The holes drilled in the centers of the bows are for the kingpins that allow the trucks to turn. The straight piece beneath the metal was left on the car. The bolsters were installed with the arch down and bolted together.

But when the east end bolster was installed, it was found there was a problem: the bolster extended beyond the sill. This meant the car was too narrow in this area.

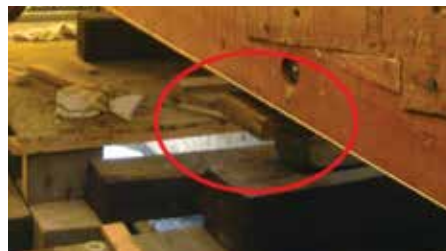
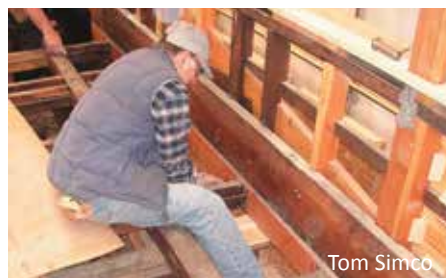
This was the sill that was replaced early on because of rot, and apparently warped or shifted during or after replacement.

So the sill needed to be shifted outward. This meant removing the old framing pieces and removing the metal bracket holding it against the outer sill. This also meant removing the outer framing pieces, loosening the tie rods, and jacking

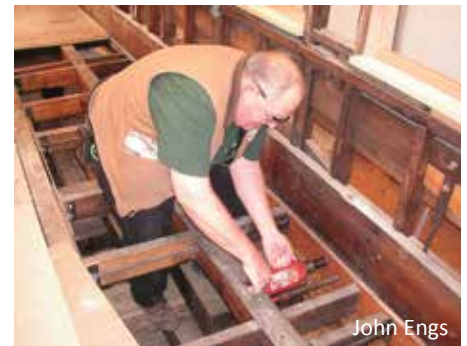
the sill sideways with a hydraulic jack. The inner end was mortised into the intermediate sill.

meant that the framing braces had to be redone as well in that segment of the sill, which then required that the tie rods needed be remade to the new and correct width of the car.

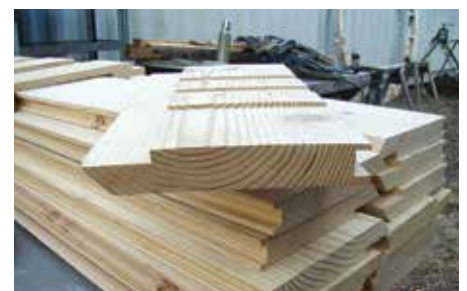
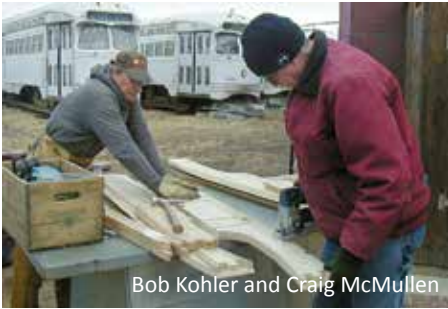
There is a groove below for the windows and a curve above to fit the pitch of the roof. The grooves along the upper side of the board fit around the verticals on the side of the car.

The boards were clamped in place be-

fore finally screwing it on to the car.
The screw holes were then filled and

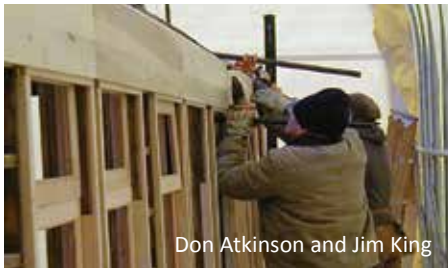
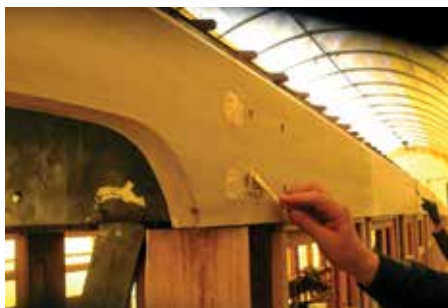
sanded smooth.
The corners replicated the original

dovetail joint. Here part of the arched end piece could be salvaged and just the dovetail corner was replaced.

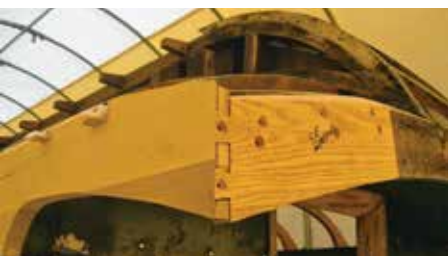
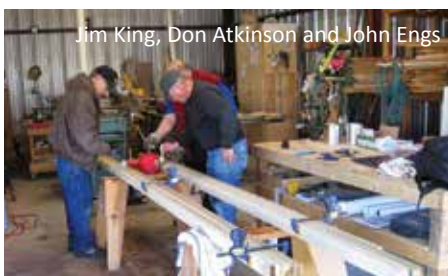
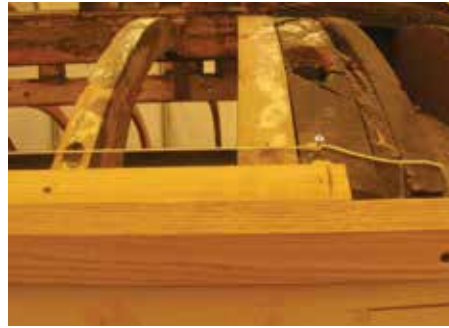
ance in 2014 was the beginning of the preparation and installation of the roof decking. It was much easier to oil the roof boards prior to installation.

The old nail holes were puttied and

sanded smooth, and new tongue and groove decking was installed, piece by piece.

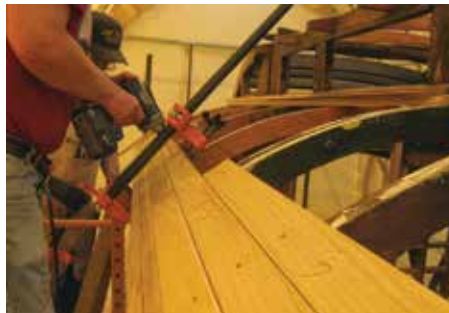
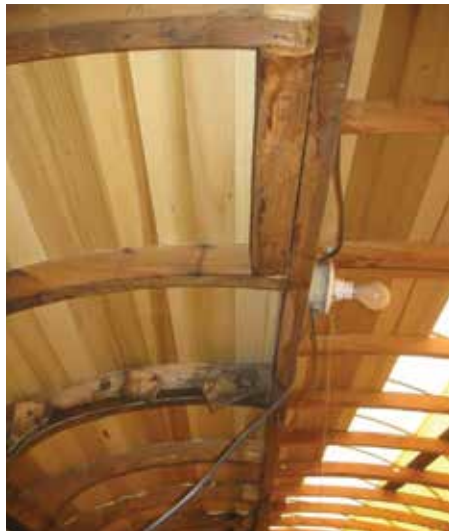
With the decking complete on the main

roof of the car, work began on topping of the clerestory.

The ends of the roof and clerestory decking posed another interesting engineering problem: how to add roof decking to a double compound curve.

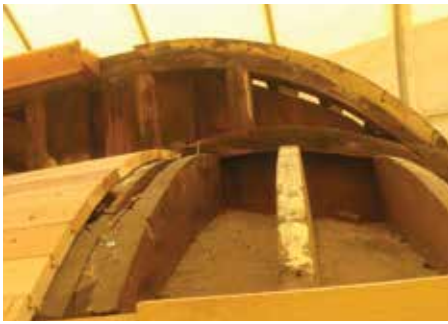
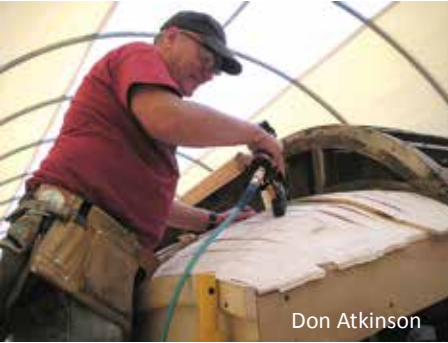
Sheets of this material were cut into strips and fastened onto the framing at right angles.

A second layer was added in the same orientation but offset a half strip width for increased strength. Filler was applied over the surface and the roof was sanded smooth to complete the job.

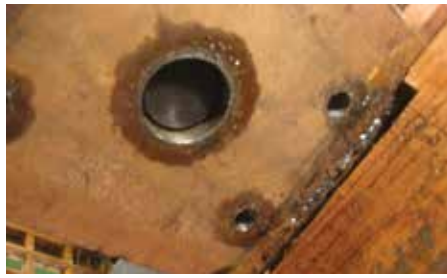
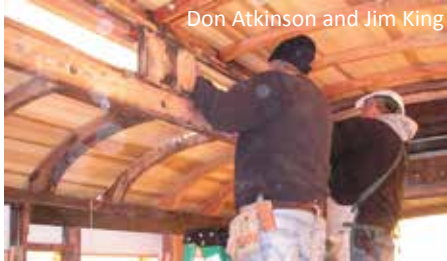
clerestory soffit. Access was an issue but working on the outside from the inside of

the car seemed easiest.

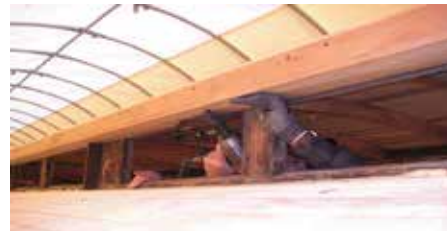
The upper sashes of the lower car win-

dows were prepared. As yet there was no glass in any of the windows.

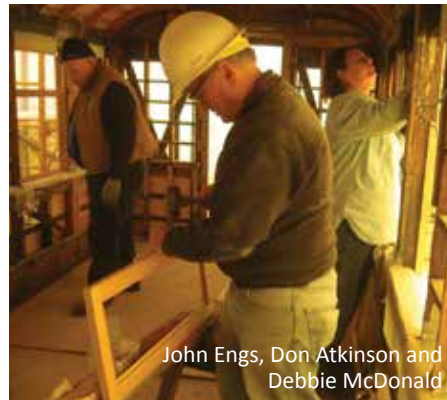
the installation of the first needle beam.

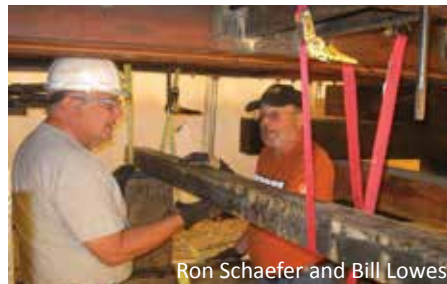
This was followed by lifting the bottom

bolster plate into position and bolting it in.

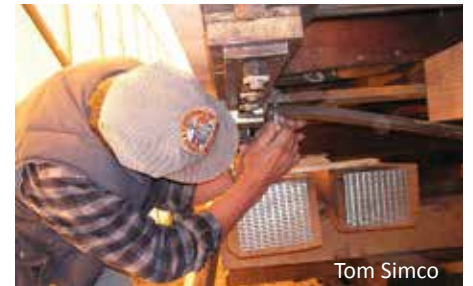
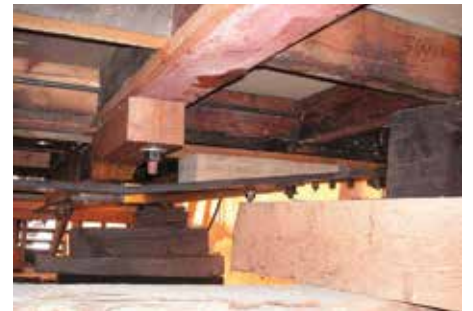
end platforms. As with the other tie rods, these help pull the structure together into one complete unit.

They tie into the end sills and continue

under the car.

riage structure took some time and a little bit of bending. The platform tie rods were in place but were not yet drilled through the platform end sills. There are six rods in each platform with three on each side.

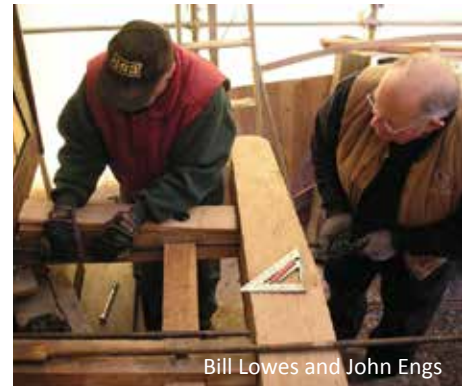
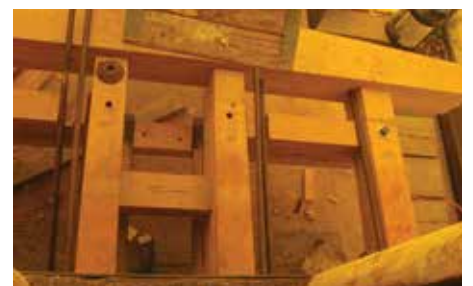
The rods had to be bent to be threaded through the sills of the car. Some of the tie rods were bent by hand, but a borrowed hydraulic bender made things easier by placing the tie rod between two

guides and jacking the center to force the bend, yet another creative solution to an

One end of the rods next to the inner sill was hooked on to the bolster. The other rod near the inner sill was hooked on to the end sill of the car and was fixed in place with a lag bolt.

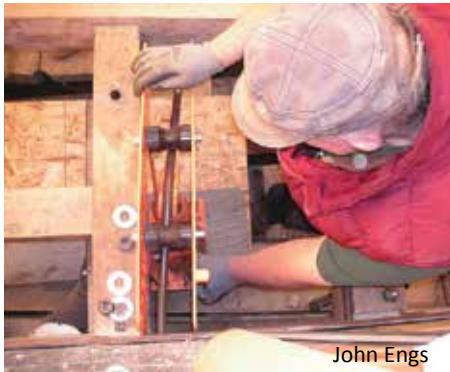
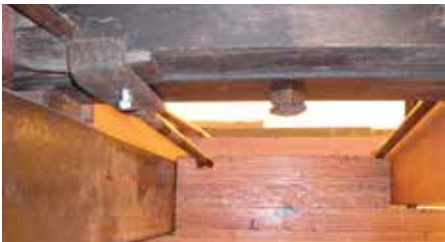
additional holes needed to be drilled with the magic drill that attaches itself to the steel magnetically.

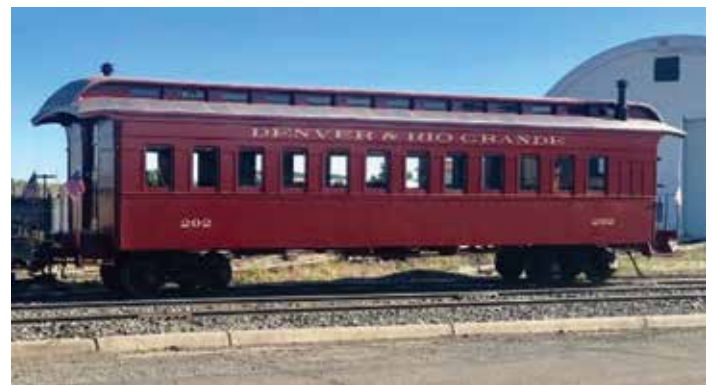
COACH NO. 292: CHARACTER-DEFINING FEATURES

1. Clerestory roof (raised center section with windows on sides of raised section).
2. Passenger-style trucks (to be replaced during rehabilitation.)
3. Letter boards on the car sides above windows.
4. Air brake system.
5. Truss rods under car for support.
6. Couplers on the ends.
7. Painted and lettered standard D&RG passenger train colors and style; red body to 1918, green body after 1918, gold leaf or "deluxe" yellow paint lettering.
8. Wood siding.

11. Many windows on the sides.
12. End platforms with doors to the interior.
13. Ceiling lamps and vents (to be replaced by LCD fittings during restoration.)

- A. Butin cast coach seat ends.
- B. Single-light round corner Jackson & Sharp-style windows.
- C. Interior wall panels and finish.
- D. Cast iron corner post decoration.

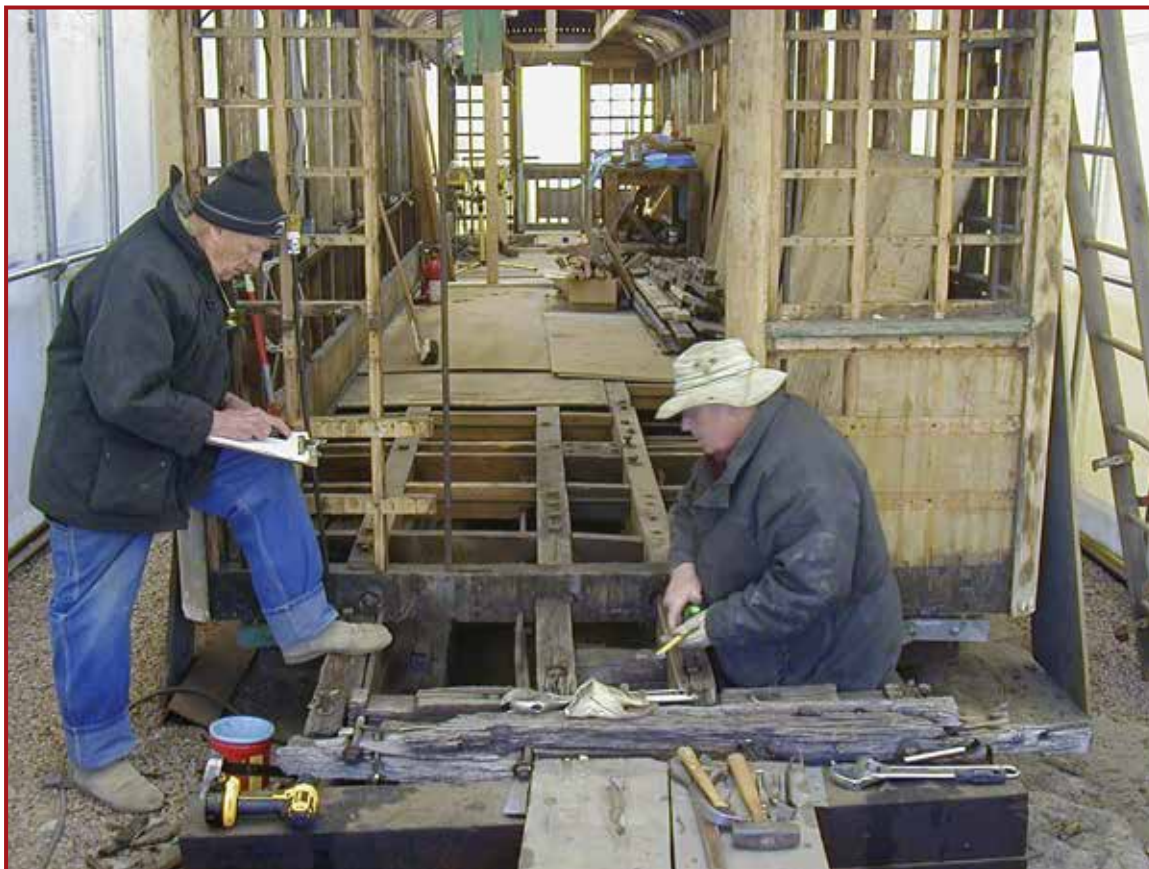
Glenn Hall and John Eng measure and take notes on the construction of one of the end platforms of Pullman Tourist Sleeper 470 near the beginning of its eleven-year restoration. *Photo by Duncan Burdick*
