C&TS Dispatch

FALL 2007

HISTORIC PRESERVATION — 2007

The June Volunteer Work Sessions

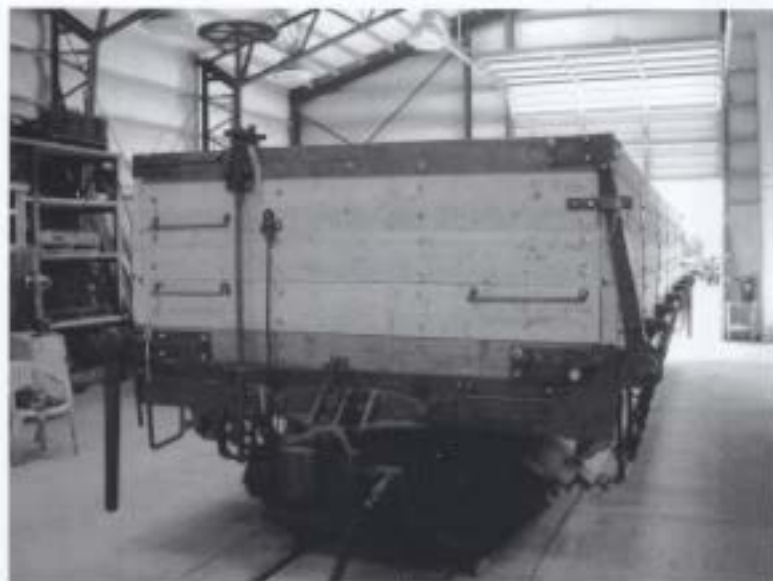
Completed drop bottom gondola 859 in the Antonito CRF. (Bill Pratt)

Following significant progress during the 2006 work sessions, all restoration work on drop bottom gondola 859 was completed during Session C. The team installed the end siding, the brake staff, adjusted the drop doors, installed the remaining safety equipment, and gave the car a coat of linseed oil. The car is finished except for painting and lettering.

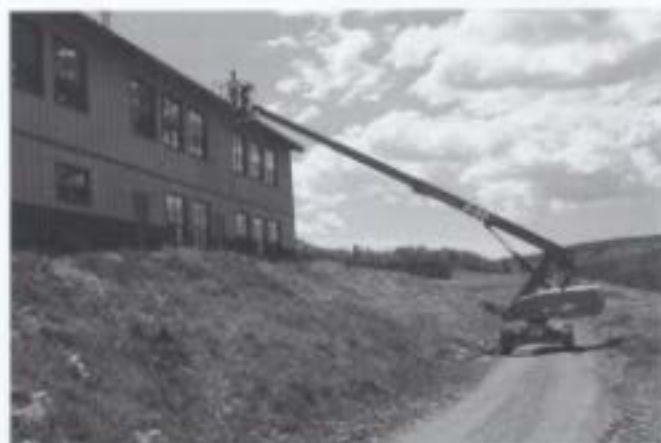
Clyde Putnam works from the self-propelled man-lift. With a 60-ft reach it allowed greatly improved access for painting the Osier Dining Hall. (Scott Hardy)

The entire north wall (kitchen end, nearest the water tank) was pressure washed, primed, and painted yellow/gold with brown trim. Likewise the portion of the opposite, south wall, that had not been painted in 2006 was washed, primed, and painted. Some trim on the east-facing upper story windows was painted or covered with a second coat. Roof trim around the entire building was painted brown or repainted as necessary. Touch up painting was done in a few areas around the building.

This year a self-propelled man-lift with a 60-ft reach was rented for the work. This was a great improvement over the use of the railroad's scissor lift and the trailer lift used in 2006. In 2006 most of the team's time was spent moving and blocking the lifts. By using the self-propelled lift this year, most of the team's time was spent doing actual work on the building rather than moving the equipment. This lift also allowed easy access for two people to virtually every location on the building (see photo).

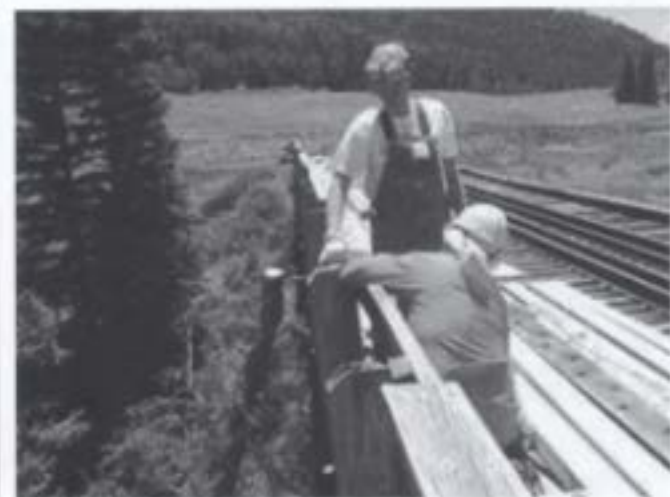
Mickey Hallum and Bob Reib repairing the Lobato Trestle handrail. (Mike McGinley)

Work during Session D focused on repair of the handrail system. The handrail system consists of three longitudinal 2x6 members, the top element has a horizontal and vertical inverted "L" shape of two boards and the middle element is a single vertical 2x6. These boards are nailed to vertical 4x6 posts located on about 90-96" centers. These posts are secured by diagonal braces and both the posts and the braces are fastened to the walkway support beams (4x6) with 1/2" square head bolts.

Most of the handrail boards were warped and about 25% were split or decayed. All sound but warped boards were forced into alignment with clamps and nailed into position, and defective boards were replaced with new ones. The process of drawing all handrails and posts into close contact and securely nailing them greatly reduced the flexibility and deflection in the walkway/handrail system.

The vertical posts and diagonal braces are susceptible to decay due to their design. Five of the 51 post/diagonal brace assemblies and one diagonal brace had to be replaced. Posts 1, 2, and 3 (posts are numbered from the Chama end of the trestle) could be reached by standing on the ground on the west end of the bridge and their replacement was straightforward. Posts that could not be reached from the ground were removed and replaced from the walkway as an assembly. The bolt between the diagonal and the post, at the bottom of the post, was too far for a person to reach while

lying on the walkway, so the assembly had to be removed and replaced as a unit. This difficult operation required all four members of the team. The post/diagonal brace assemblies weighed between 110 and 130 pounds. Precautions were taken to secure clamps and wrenches with lines so that they could be recovered if dropped.

The repairs conducted in this session are not a complete rehabilitation of the bridge walkway/handrail, but merely a correction of immediate safety conditions. In order to plan future repair efforts, the team conducted a survey of all of the posts and diagonals. A few are recommended for replacement in 2008, and some of the others need to be replaced by 2009 or 2010.

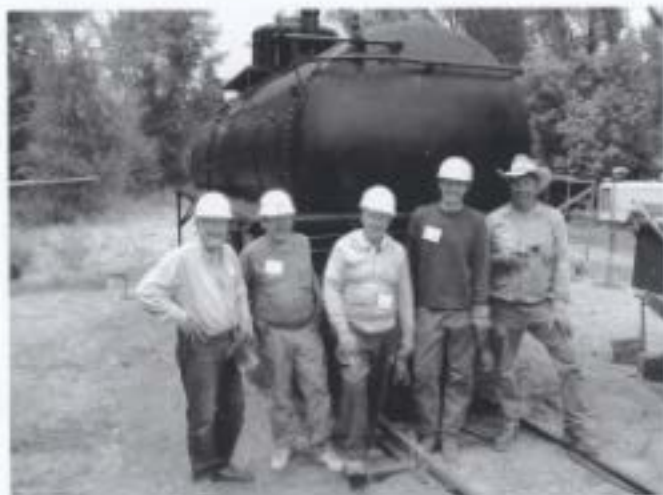
Gary Collins, Keith Lemons, Clark Bradley, Dave Collins and Andy Graham proudly stand beside freshly-painted UTLX tank car 12961. (Sandy Hogan)

The cars were completely sandblasted to achieve an acceptable surface for painting. The cars were then primed and finish coated.

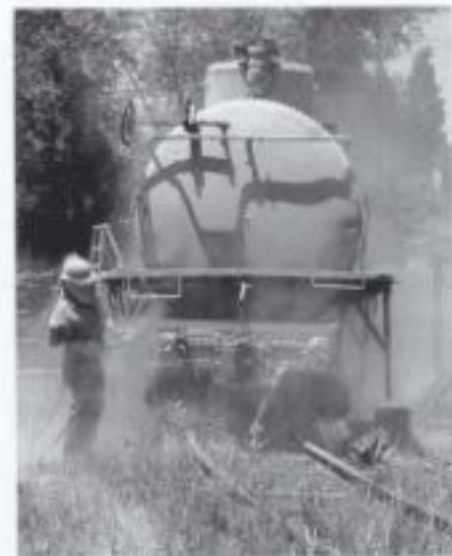
Clark Bradley is sandblasting the B end of UTLX tank car 12961. (Sandy Hogan)

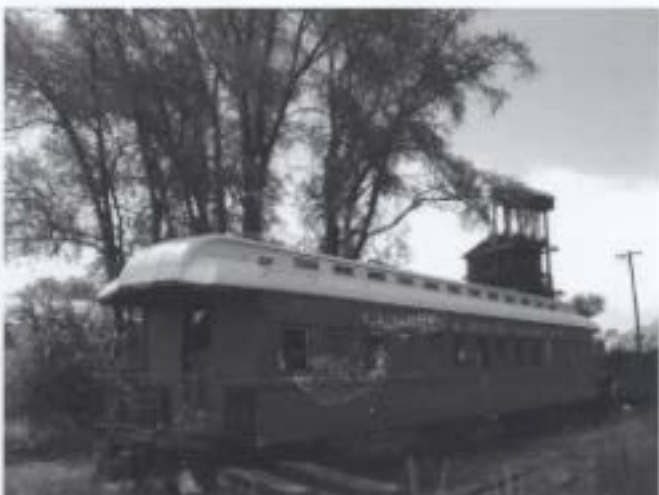
Hinman coach with new roof. (Phil Nissen)

Therefore, work focused on repair of the roof, which had been leaking. Chama recently had experienced very strong wind and the Hinman car had part of its canvas roofing blown loose. It was apparent that the roof needed more extensive repairs than initially thought; in fact, it needed to be replaced to prevent further damage. After much research it was decided that replacing the roofing with the same canvas material made little sense. It would need to be re-treated with waterproofing annually or every other year at best. After thorough review of the benefits, it was decided that a neoprene underlayment known as EPBM would be the best roofing to use on the Hinman. Materials were ordered prior to the work session. The Hinman was moved to a location in the Chama yard where scaffolding would not interfere with daily movement of locomotives and cars on or near the main line. Scaffolding was erected along one side of the car. Four of our crew unloaded the roll of EPBM, contact adhesive, and heat reflective paint and placed it on a flat car near the Hinman, while part of the team began stripping off what was left of the canvas roofing. This exposed many areas of rusted metal that had been leaking water into both the interior of the coach as well as down through the sides of the car. It was determined that this leakage was what had been causing the lower body of the car to rust. Once the roof surface was scraped and wire brushed clean of tar, old canvas residue, and flaky rust, the larger rust holes were patched with caulking and Bondo.

Scraping and patching holes occupied the rest of the session's first day and much of the second. Meanwhile, one of the crew made a template and replaced the missing section of ceiling paneling with hardwood veneer plywood. The source of the leakage that had destroyed the original panel was determined to be an exposed roof vent. After the paneling was completed, replacement vent covers were made from galvanized sheet steel and mounted on the roof. By the end of Tuesday afternoon, the first section of EPBM was cut and made ready to apply to one end of the upper-

most roof. Contact adhesive was applied to both the metal roof and the 52" wide and 60" long sheet of EPBM. Four team members attempted to install this piece but found it too large to handle. Once it made contact with the adhesive it could not be pulled loose and repositioned. It had to be torn off.

The roofing was entirely replaced and coated and should last indefinitely. No subsequent maintenance should be required, although the roof should be inspected at a future date to make sure no sections are coming loose and that no water or ice is getting underneath. Some caulking around the roof jacks and tank hangers would be beneficial along with a bead of caulk applied to the seam where the roofing butts the clerestory windows as extra prevention. There are also at least three cracked clerestory windows for which replacement glass had already been cut. However this project had to focus on the roofing and did not have time to address windows. They are not leaking and are not a glaring defect in the appearance of the car at this time.

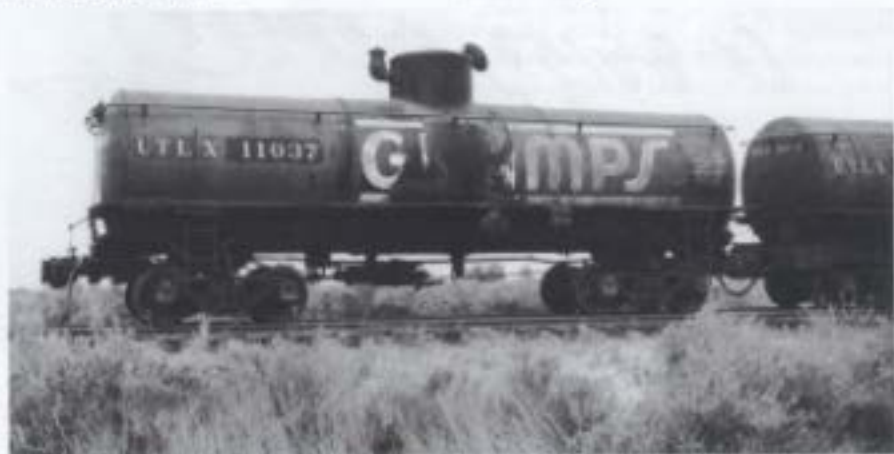
Gramps tank car, UTLX 11037, one of the frameless tank car bodies donated to the Friends. The photograph is from the Richard L. Dorman Collection of Narrow Gauge Railroad Photographs at the Friends of the Cumbres & Toltec Scenic Railroad. By John Maxwell, 3 July 1959, at Alamosa, Colorado.

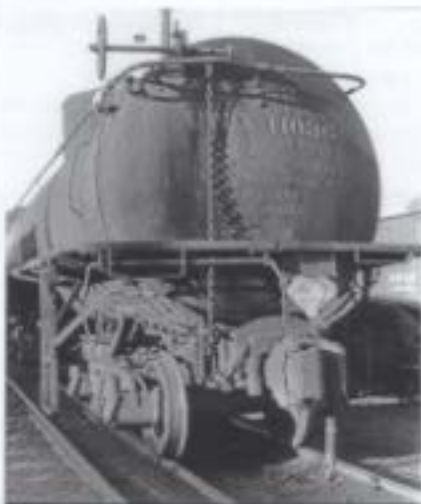
Brake end of UTLX 11036 showing the frameless construction. This is one of the frameless tank car bodies donated to the Friends. The photograph is from Richard L. Dorman Collection of Narrow Gauge Railroad Photographs at the Friends of the Cumbres & Toltec Scenic Railroad. By R. S. Polkinghorn, August 1964, at Alamosa, Colorado.
